**Third Party Evaluation of  
Plan Scheme of  
Department of Posts  
“ESTATES MANAGEMENT”**

**REPORT**

**17<sup>th</sup> July 2017**

**Indian Institute of Public Administration**

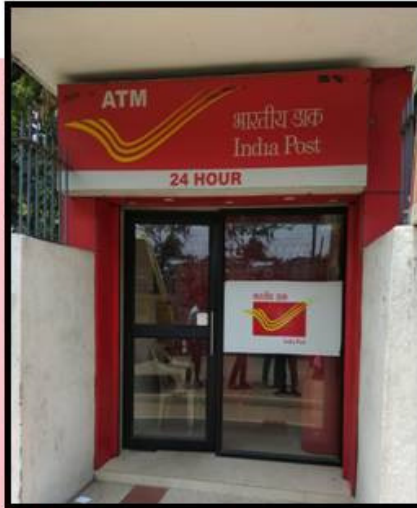
**ATM ,GPO ,Patna**

- (i) In front of GPO Patna, ATM room was found in fully functional mode.
- (ii) It was constructed in October 2015 with 8 ft x 10 ft dimension.
- (iii) ATM was reported to have remained out of order till 30 minutes for a week during the past 90 days.
- (iv) The reason assigned to this non functional half an hour was power shortage.
- (v) The other identified problem was the router having got burnt.
- (vi) However, in all the 44 ATMs of Bihar, Patna GPO ATM scores second position in number of commercial transactions.

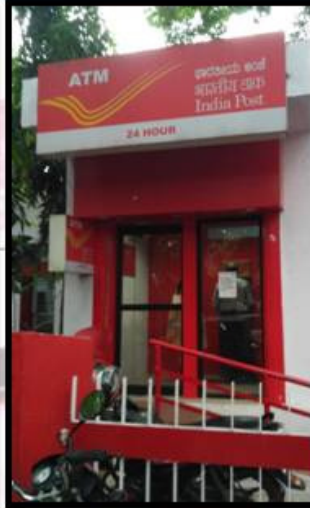
**Jalahalli, Bengaluru**

- (i) In Jalahalli in Bengaluru, the size of the ATM room is 10x10 sq.ft. and it was found to be well constructed with a ramp for disabled persons. ATM machine was found to be operational and serving its purpose even when the air conditioner was not working because of power problem.
- (ii) In GPO Bengaluru and HPO Mysuru, the ATM rooms were well constructed, however there was no ramp facility. The ATM machines were working well without any complaints.

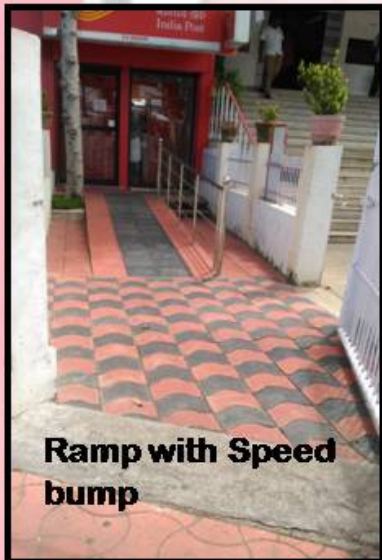
**GPO ,Thiruvanthapuram**

In Thiruvananthapuram, the ATM was within the boundary wall of GPO and adjacent to the GPO building. Though the ramp has been provided at the ATM, but the accessibility to ramp by elderly and people with disability was questionable as the entry from GPO was via its compound, which was filled up by parked cars, leaving no space for easier movement and the other main entry to the ATM is blocked by speed bump structures to avoid rain water entering inside the premises. ATM machine was found to be operational along with functional air conditioner

**Ramp with Speed bump**

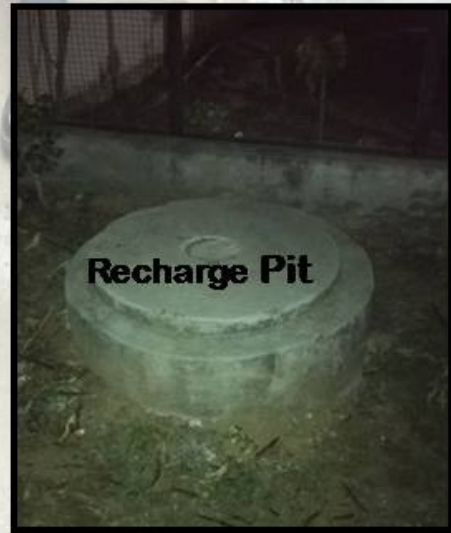
**Sub PO, Kharawa**

S. N.	Name of the Post Office	Year of construction	Whether working well	Under-ground storage facility available	Maintenance/repair required	Remarks
1.	Kharwa, Ajmer division	2016		Yes	No Problem	First rain after construction is awaited
2.	Shastri Nagar, Jaipur	2014	Yes	Yes	No Problem	Roof top rain water from PO is connected with storage tank provided in campus of staff quarters. Also rain water from staff quarters' roof is collected , stored and used for recharging ground water table.
3.	CPMG, Thiruvananthapuram	2014	Yes	No	No Problem	The roof top rain water harvesting has been immensely beneficial to the staff especially during the drought season.
4.	Jalahalli	2014	Yes	No	No Problem	Use for ground water recharge

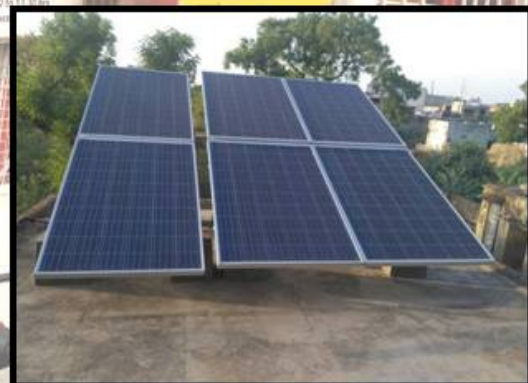
**Sub post office, Bandanwara**

- (i) In Bandanwara District Sub-post Office located in Beawar Division of Ajmer, Rajasthan solar power pack was installed in January 2017.
- (ii) It has capacity of 1.5 kilo watt. So far the SPP has been functioning well.
- (iii) All the electrical equipments in the office - 6 tube lights, 4 ceiling fans and one desktop computer are running on SPP.
- (iv) It has 7-8 hours of battery back-up.
- (v) Since its installation, no major difficulties have been encountered for running the SPP. There was no requirement of any major repairing and maintenance. Now the electricity bill is negligible.

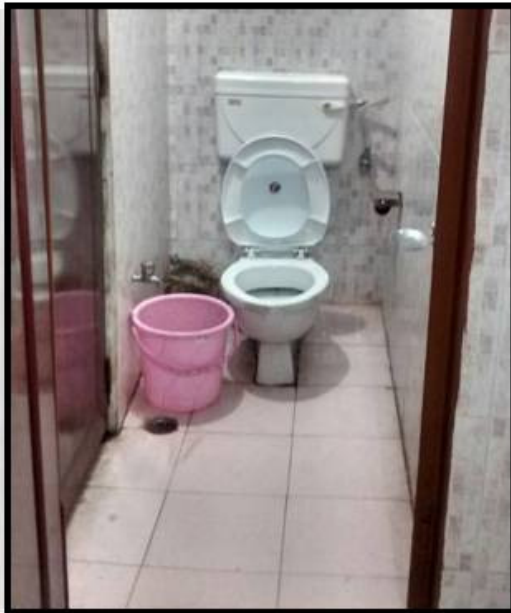
**Ladies Toilet , CPMG  
Shilong**

- (i) In Shillong CPMG the ladies' toilet which was repaired under gender concern sub scheme was located on fourth floor near the elevator of the CPMG building.
- (ii) An amount of Rs.1,50,000 was spent on repairing work.
- (iii) The toilet has enough water, regularly cleaned and easily accessible by the women employees of the office.

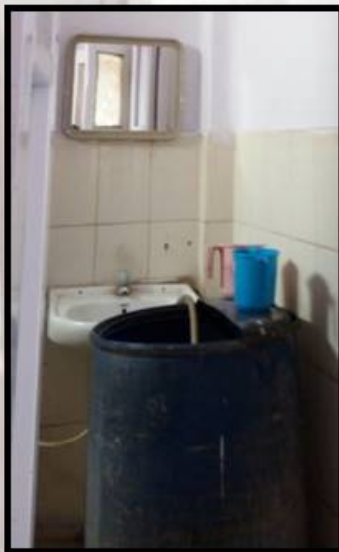
- (i) In Mysuru HPO, ladies' toilets were found to be renovated.
- (ii) However, toilet did not have proper water supply leading to inconvenience to the users.
- (iii) It was also found that a retiring room provisioned for ladies staff was converted into a store room thereby depriving the ladies from the facility of retiring room

**HPO , Mysuru  
No Proper Water  
Supply, this tank is  
used to store water**

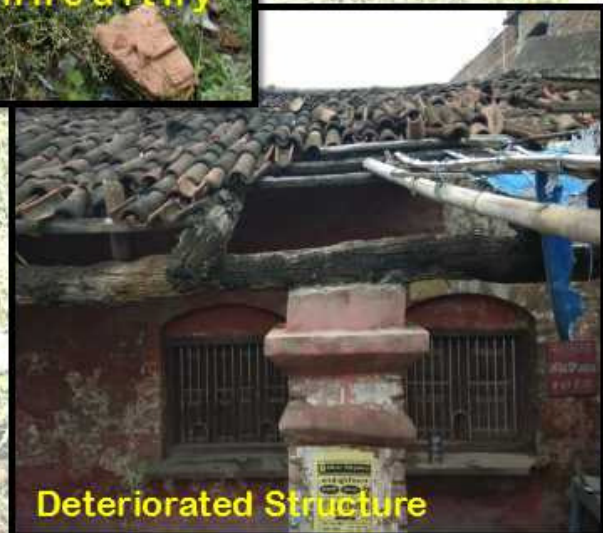
Deteriorated Structure

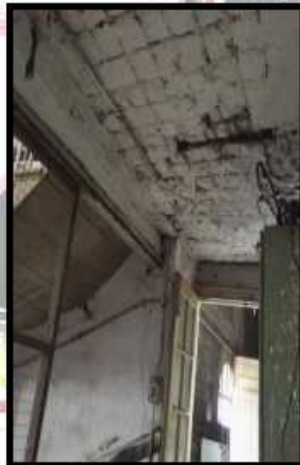
- (iv) As per the information given by Assistant Director Postal services (Legal & Building) and as observed by the evaluation team, Mumbai GPO heritage building is not properly maintained and conserved.

- (v) In rainy season, large portion of the building is having seepage on the wall and ceilings. To repair this seepage issue, only plastics are being tied on the roofs and coal tar is being painted on the walls. This prolonged seepage has weakened the building and at various places, growth of fungus and algae has been observed. The ceilings, iron bars are rusted and weakened due to seepage. The ceiling is so weak that building materials like cement, concrete have started falling off. As per the information given by the staff, there were 3-4 such incidents in past one month, where some staff members were luckily saved from serious injuries.

Deteriorated Roof Structure,GPO,Mumbai

- (vi) Rs. 51 Lakh was received from FY 2012-13 to 2016-17 and almost entire amount was spent only on arresting seepage and water leakage.
